KIRKLAND & ELLIS LLP

# PG&E Independent Monitor Report of November 19, 2021

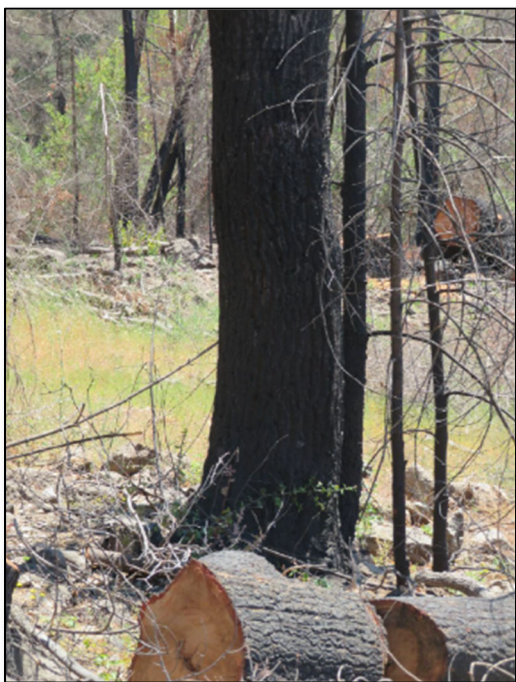
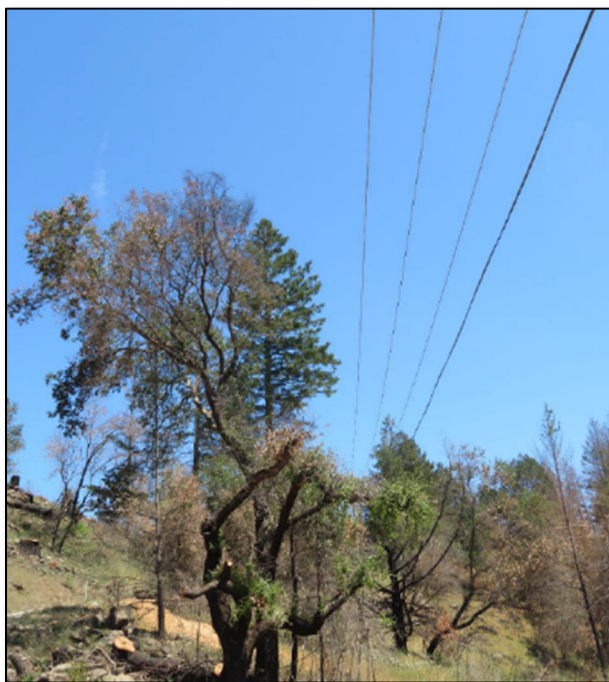
Below is a hazard tree with fire damage identified by the Monitor team.

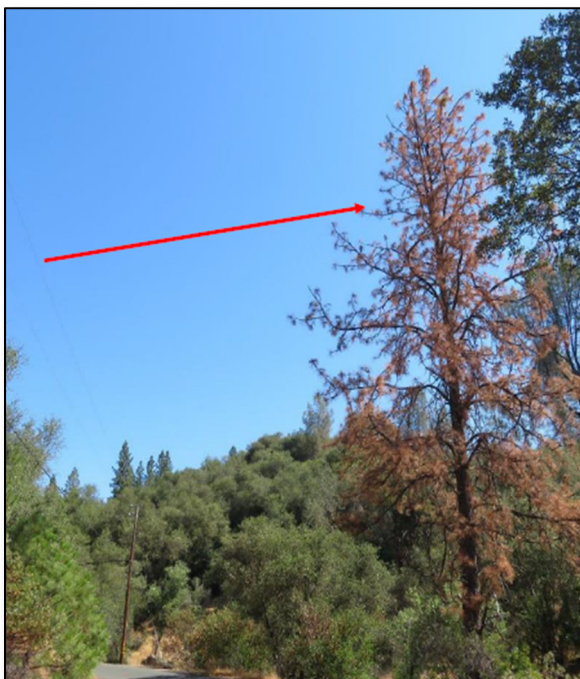
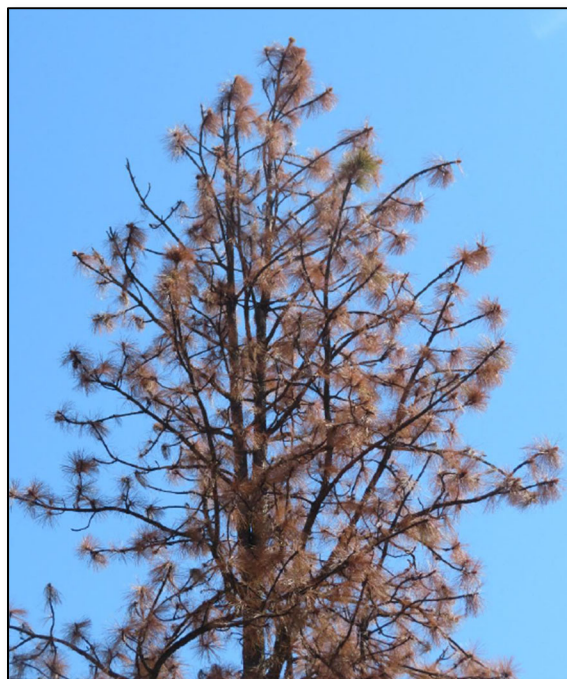
Below is a hazard tree that was dead or dying identified by the Monitor team.

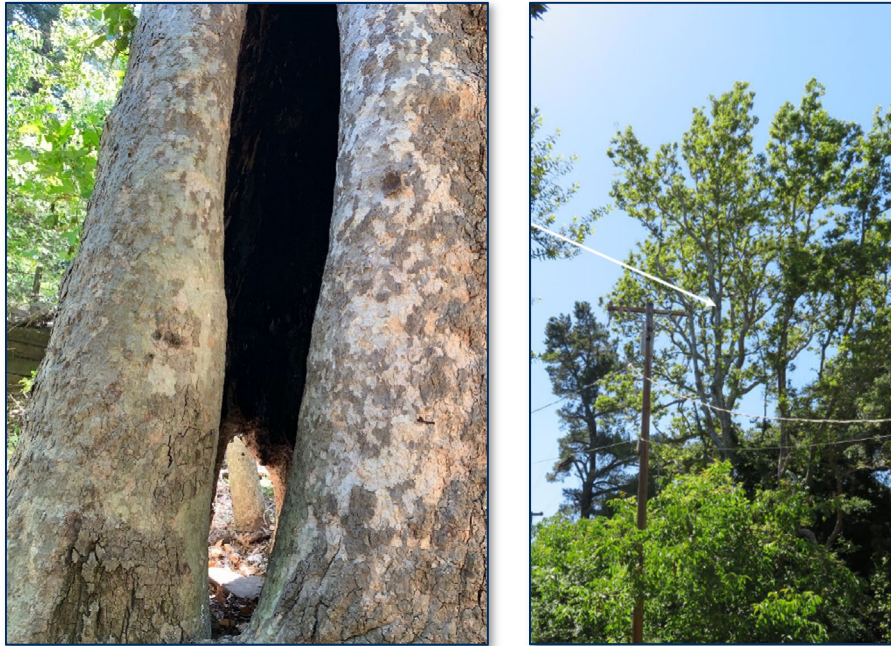
Below is a hazard tree with decayed cavities identified by the Monitor team.

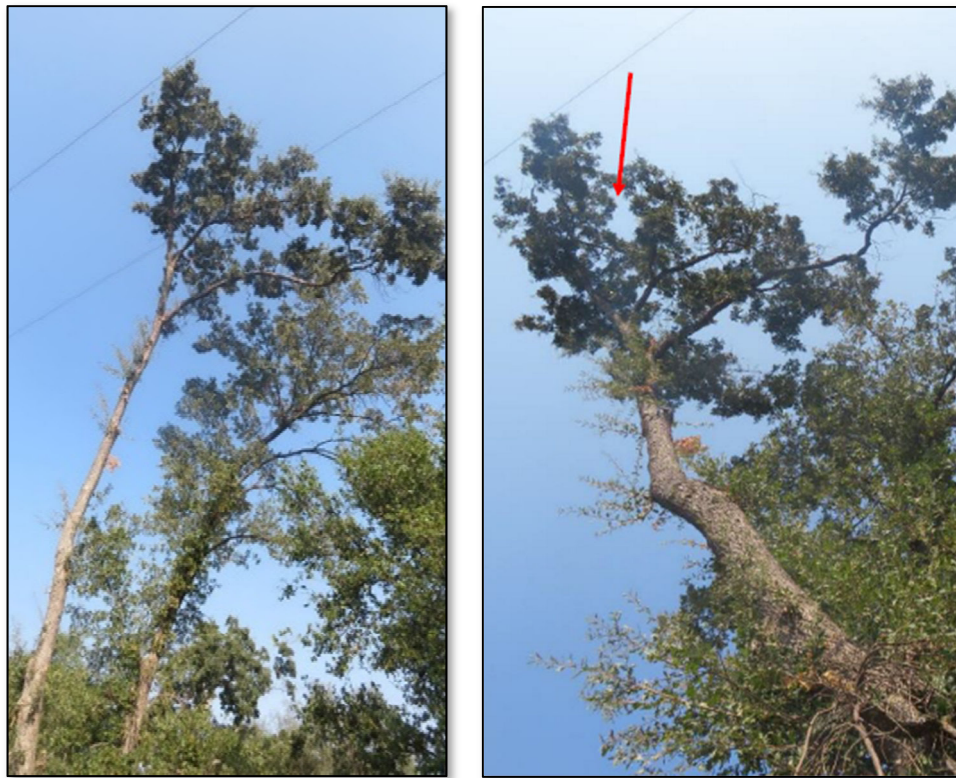
Below is a hazard tree with poor taper identified by the Monitor team.

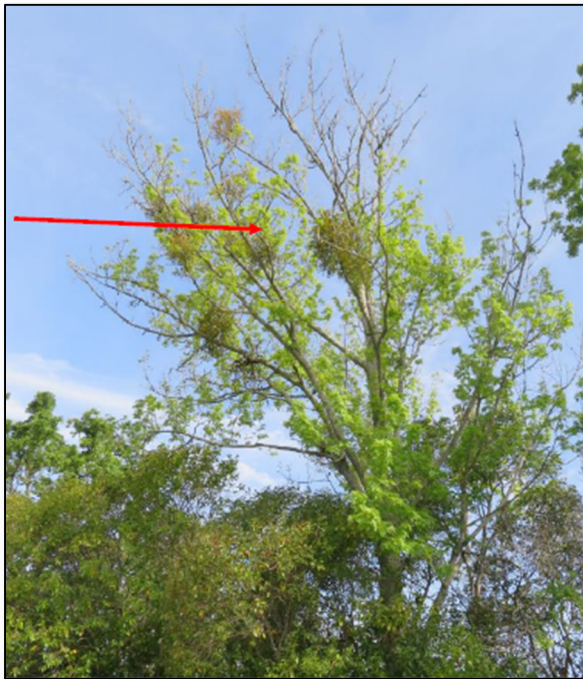
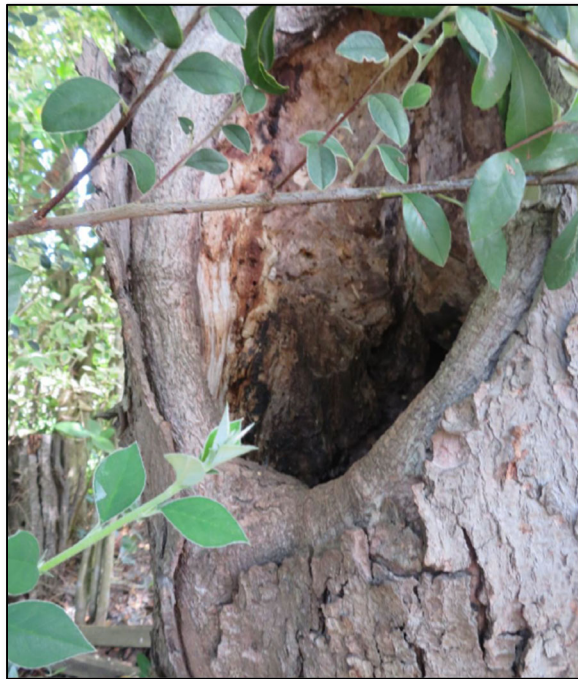
Below is a hazard tree with branch dieback and decayed cavities identified by the Monitor team.

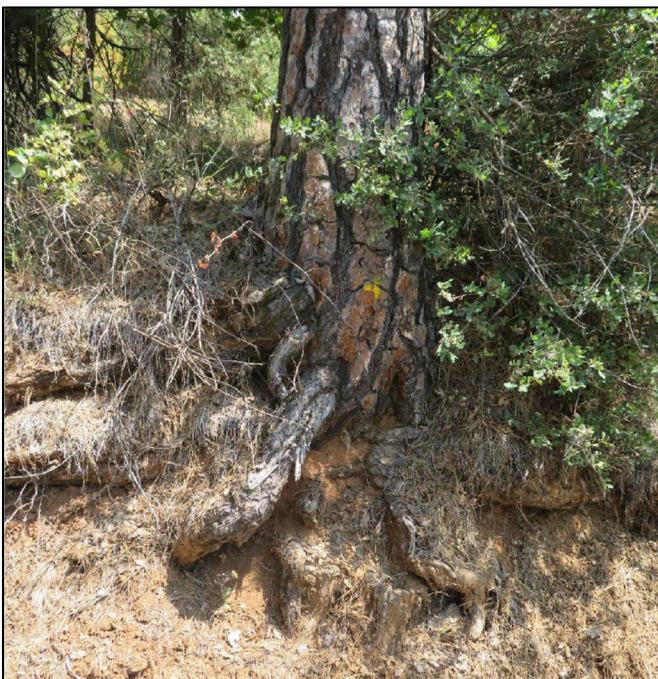
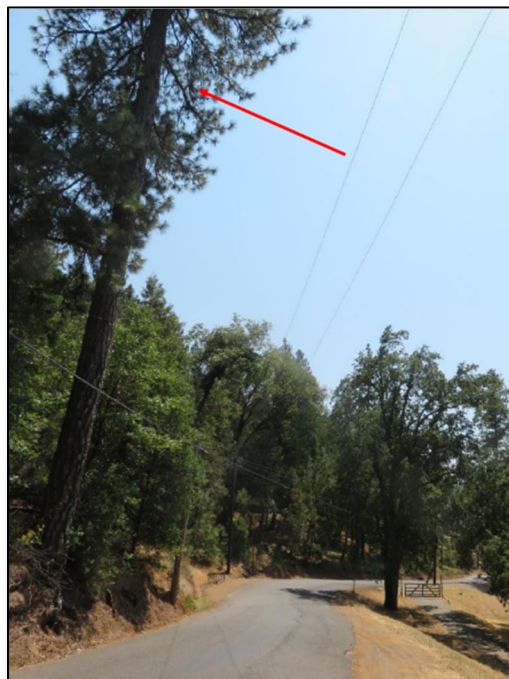
Below is a hazard tree with exposed roots identified by the Monitor team.

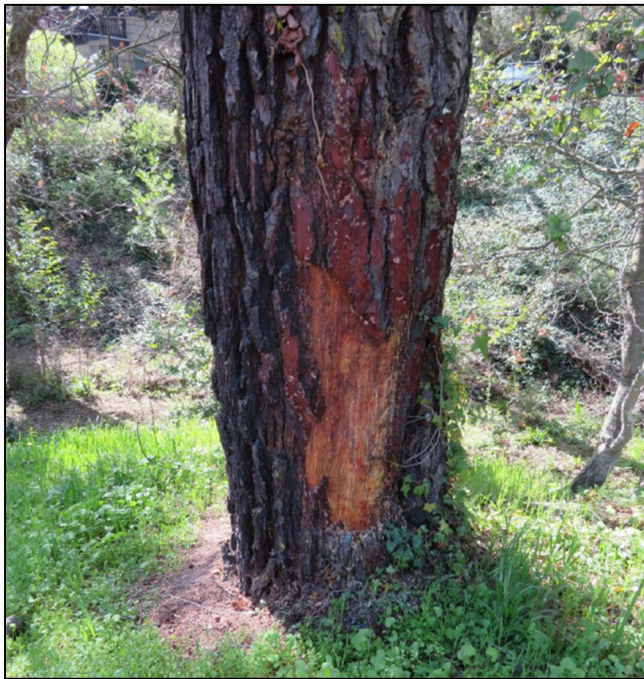
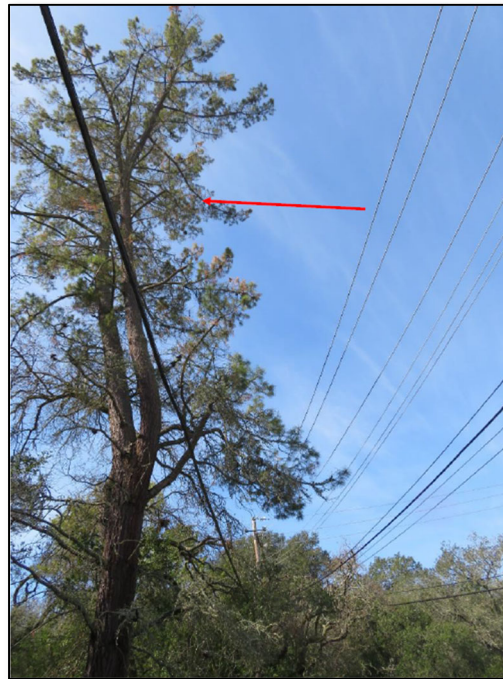
Below is a hazard tree with mechanical damage identified by the Monitor team

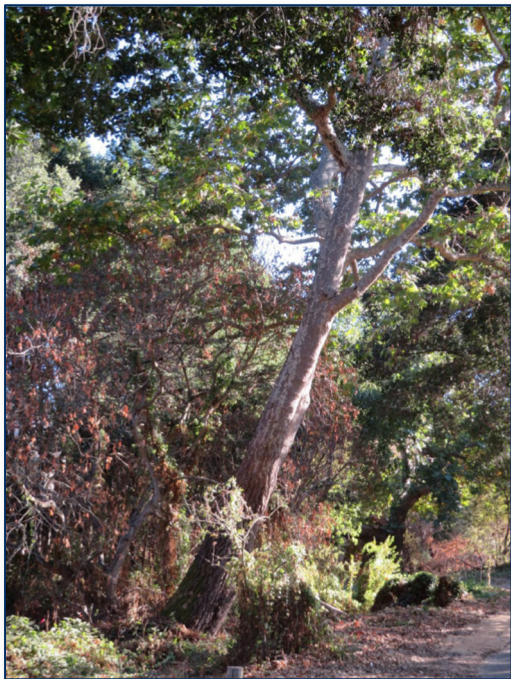
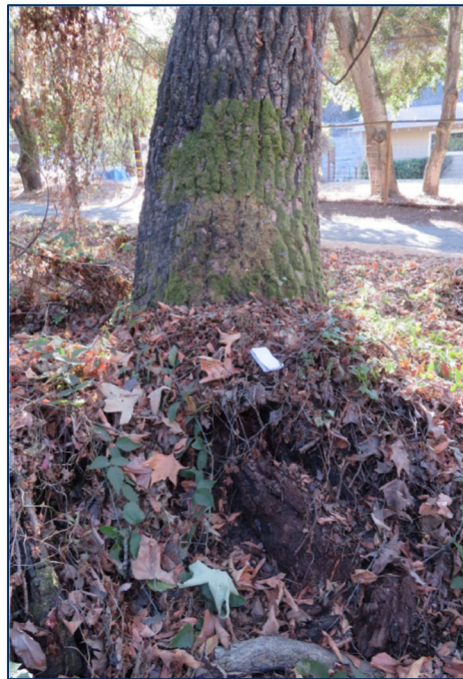
Below is a hazard tree uprooting at the base identified by the Monitor team.

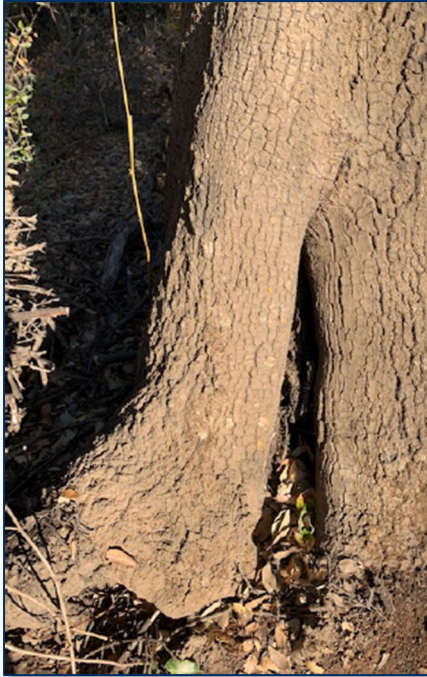
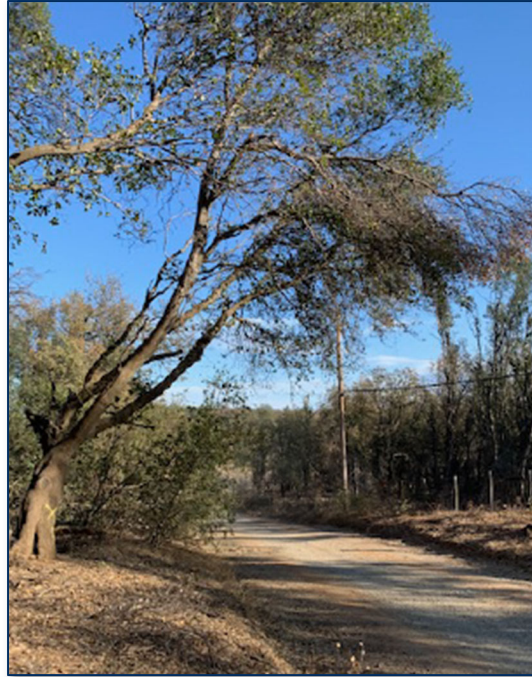
Below is a hazard tree with cavities, heart rot, and cracking identified by the Monitor team.

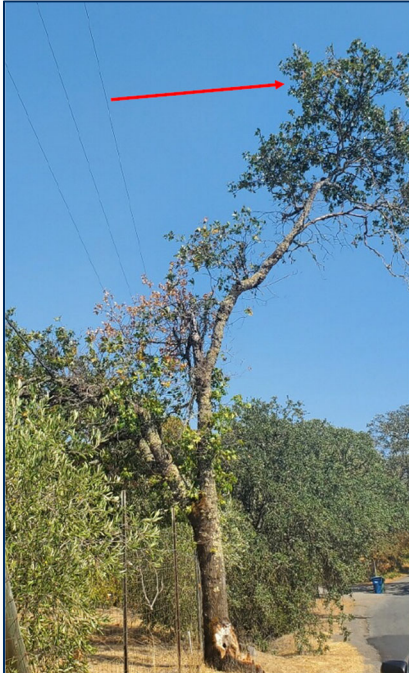
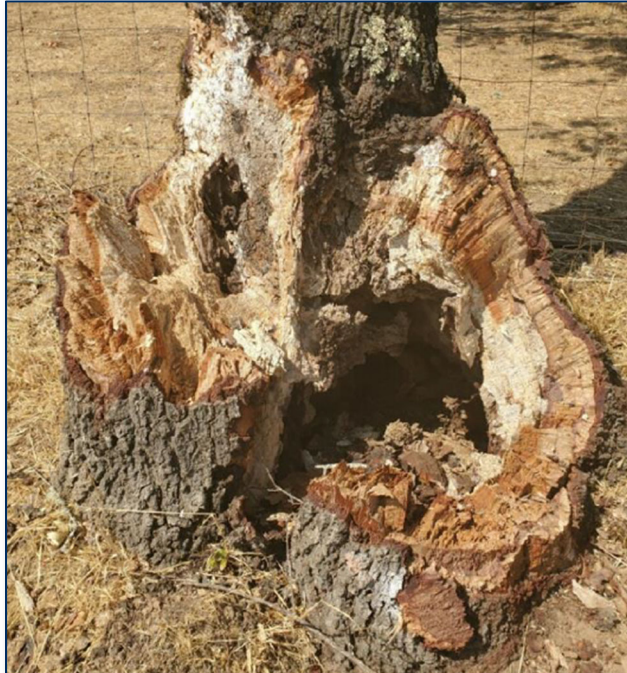
Below is a hazard tree with cavities and rotting identified by the Monitor team.

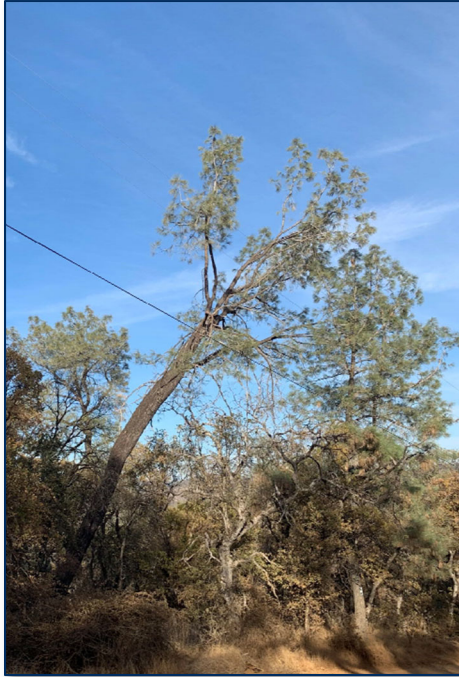
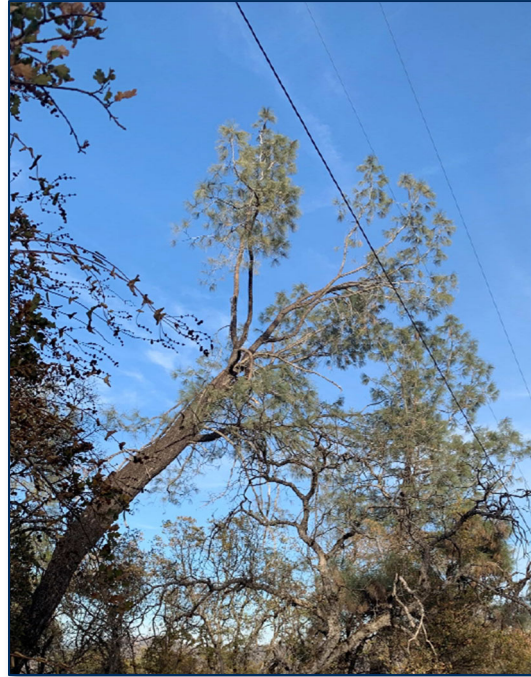
Below is a hazard tree with severe lean towards primary conductor identified by the Monitor team.

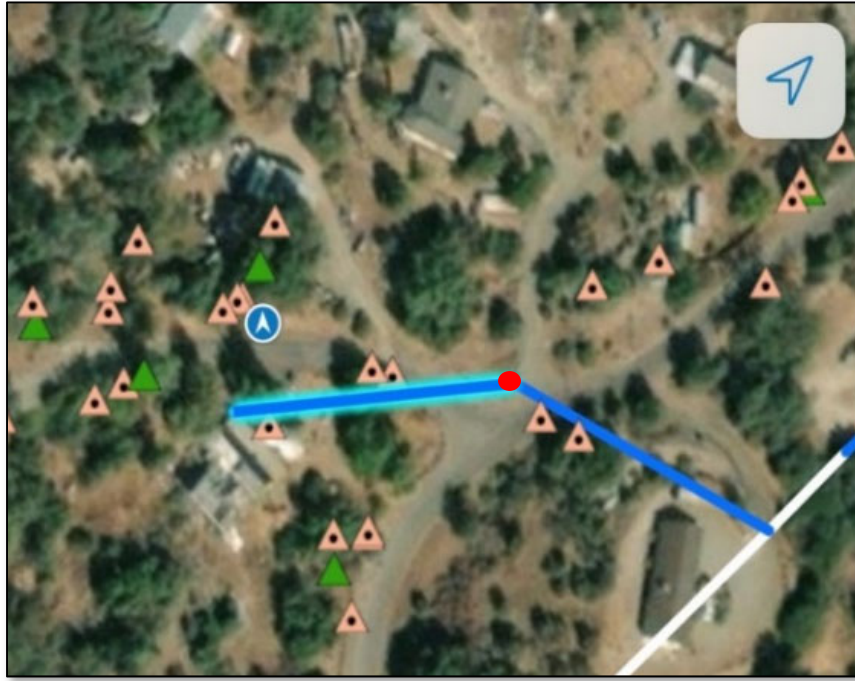
On CIP\_BF126-A14\_638206, the actual location of a pole (blue circle with white arrow) was ~200 feet away from the location of that pole on the Arc Collector map (red circle).

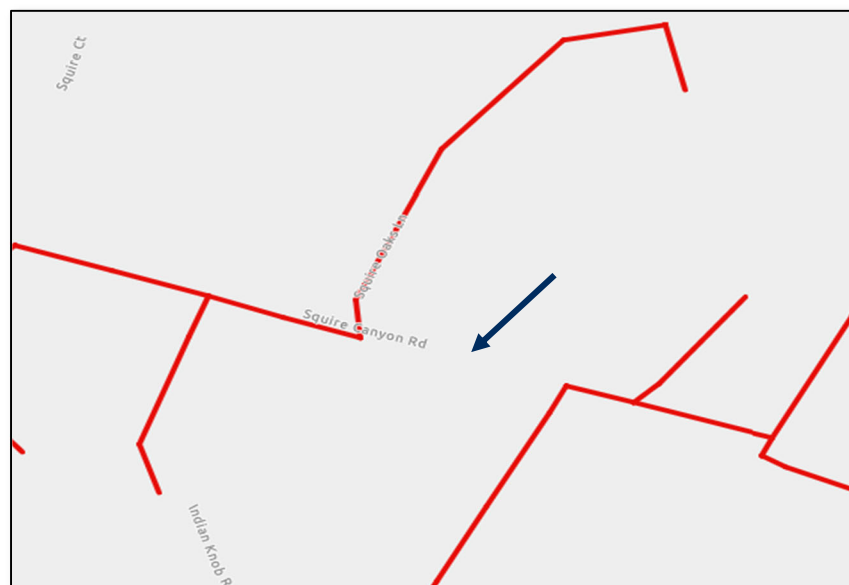
Near CIL\_AY138-L08\_143892, the Monitor team informed PG&E on 10/30/20 of a radial clearance issue on a segment that was missing from the Arc Collector map. That segment is still missing in 2021.

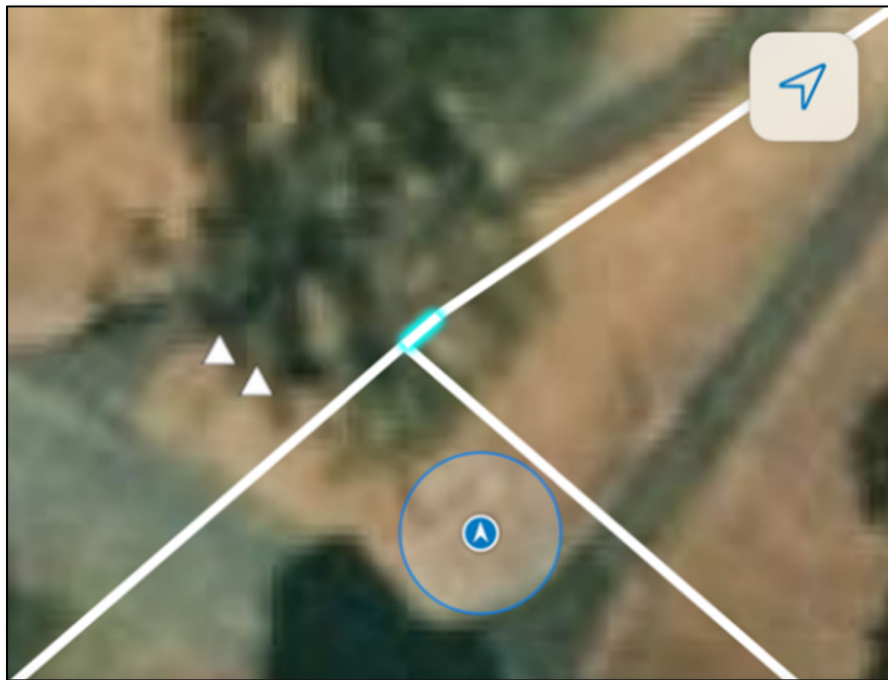
CIE\_B127-B19\_1727589 is a seven-foot long segment that does not correspond to a full span of primary conductor.

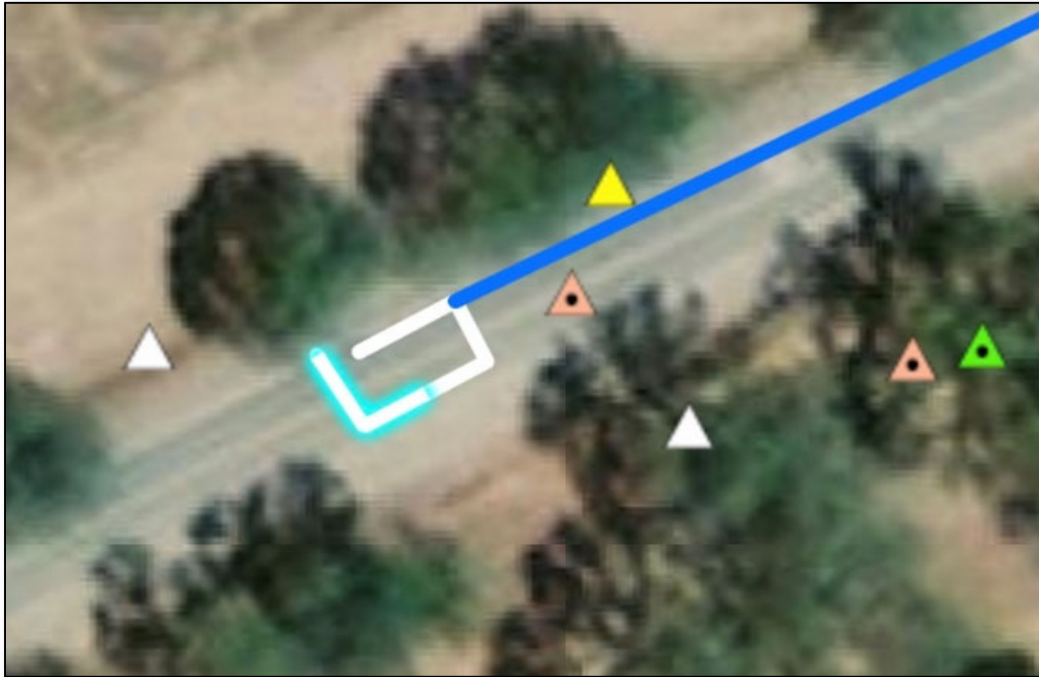
CIE\_AO108-B15\_1774125 (and the adjacent L-shaped segment) do not exist in the field.

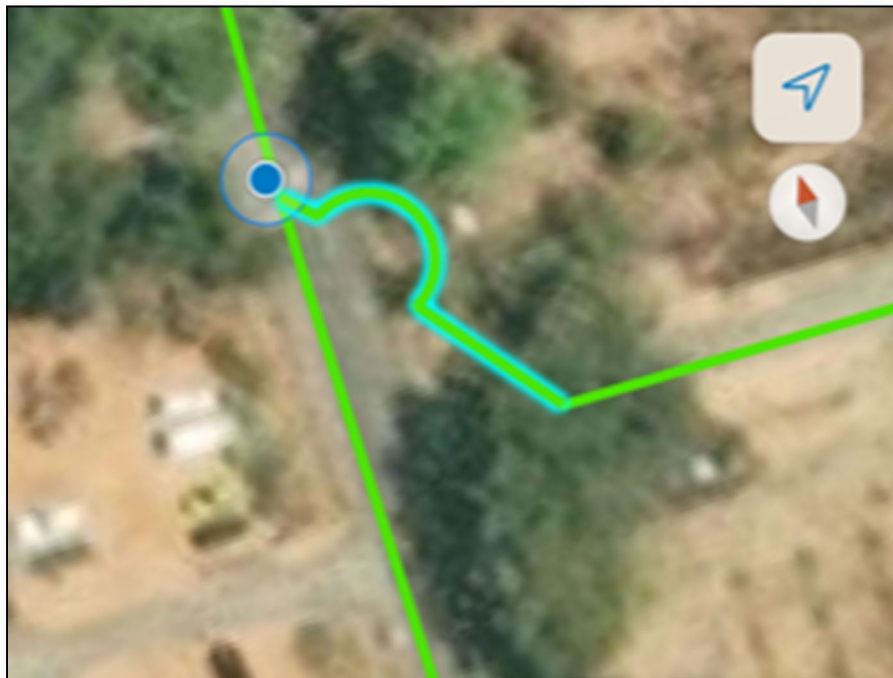
CIE\_AP120-K24\_1757184 appears curved on Arc Collector, but the segment is a straight line in the field.

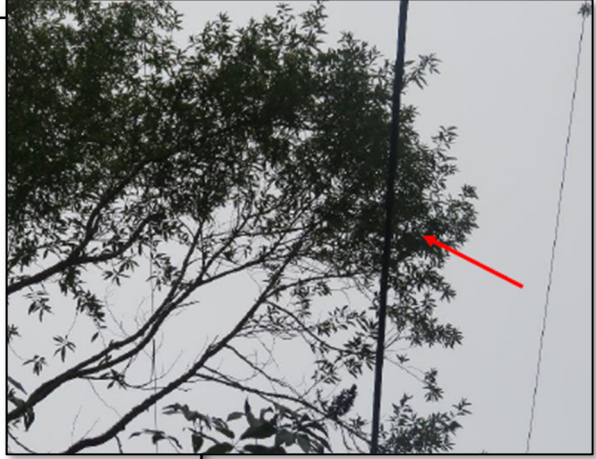
Near CIE\_AJ120-K23\_1744484, the Monitor team observed five trees that had been marked as “Tree Work Complete,” but the Monitor team observed that the prescribed tree work had not been performed.

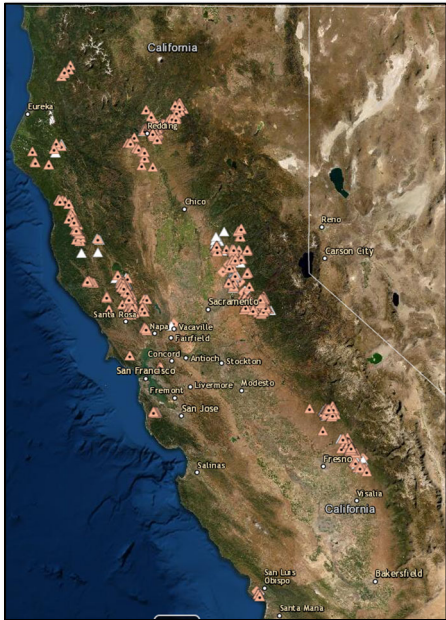
The below vegetation point record shows a tree with a Tree Assessment Tool result of “Abate” but a Status of “No Work Required Under EVM.” The map shows 1,541 vegetation point records in Arc Collector with the same discrepancy between the Tree Assessment Tool result and the Status.

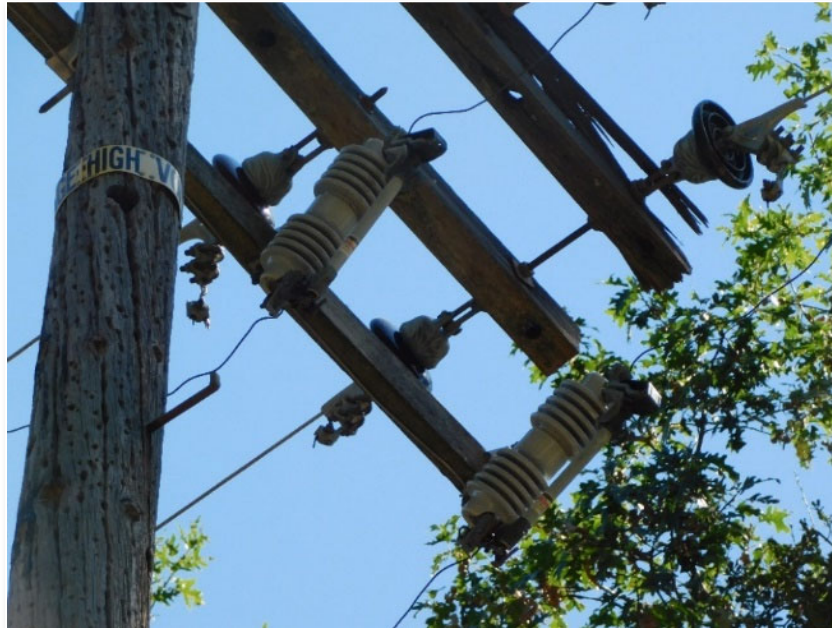
Below is a severely damaged crossarm the Monitor encountered in a Tier 3 HFTD. The Monitor team immediately reported this condition to PG&E, which then dispatched a field team that arrived on site within approximately two hours.

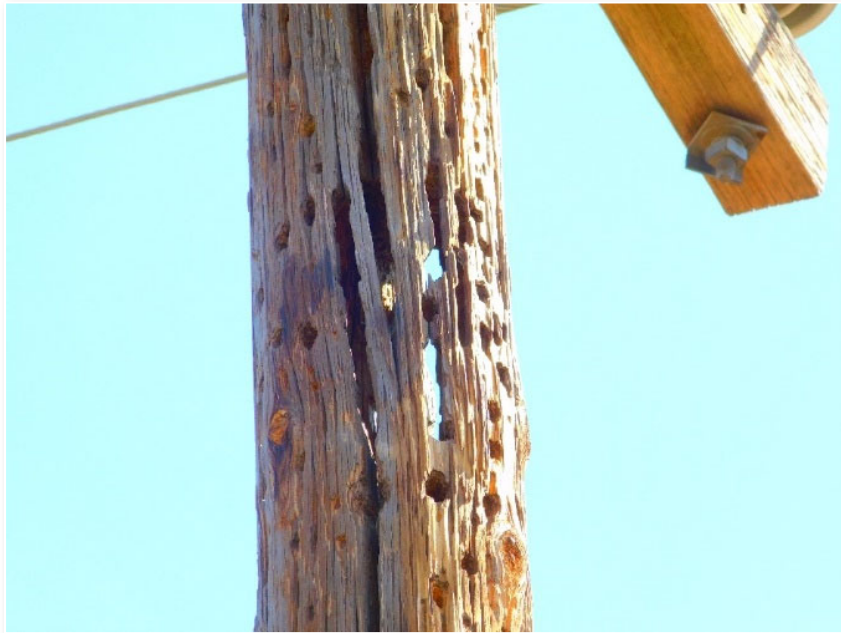
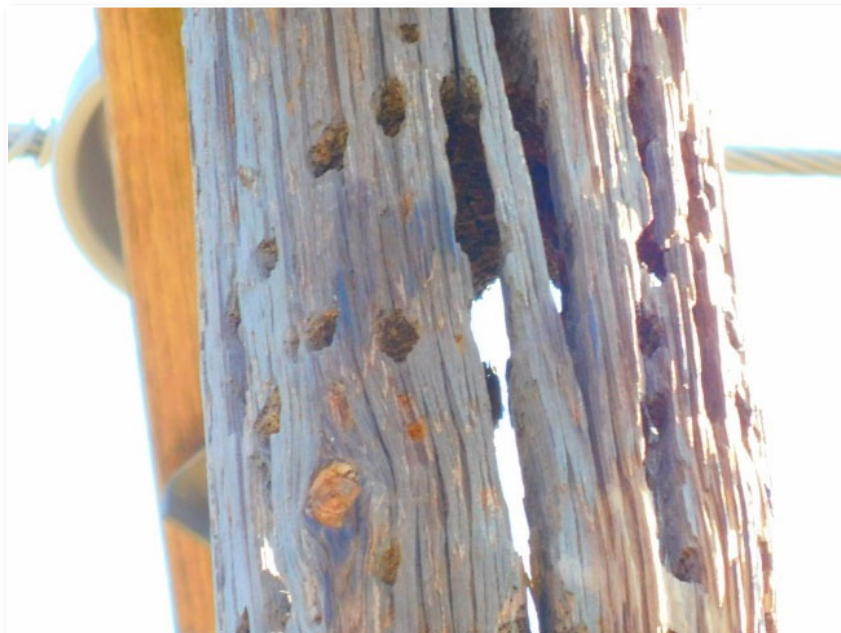
Below is a pole with severe cracking and decay that the Monitor team found in a Tier 2 area and immediately reported to PG&E. The Monitor team confirmed that PG&E replaced the pole the same day.

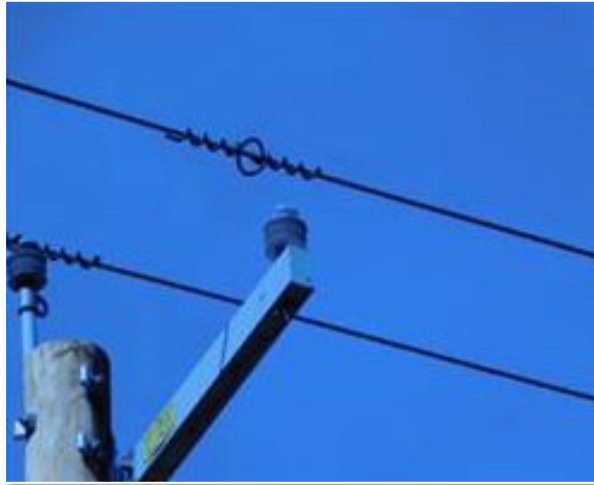
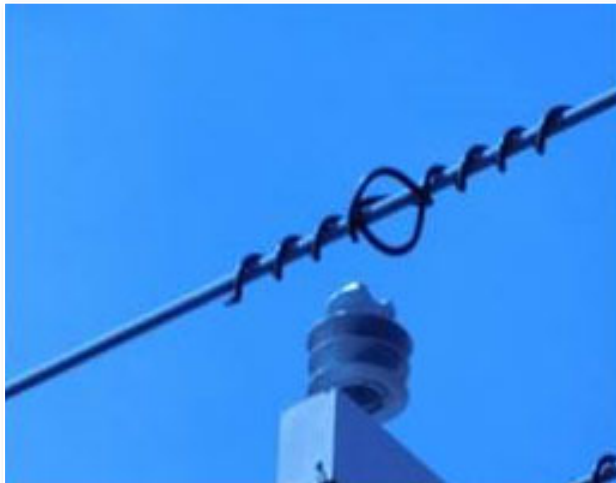
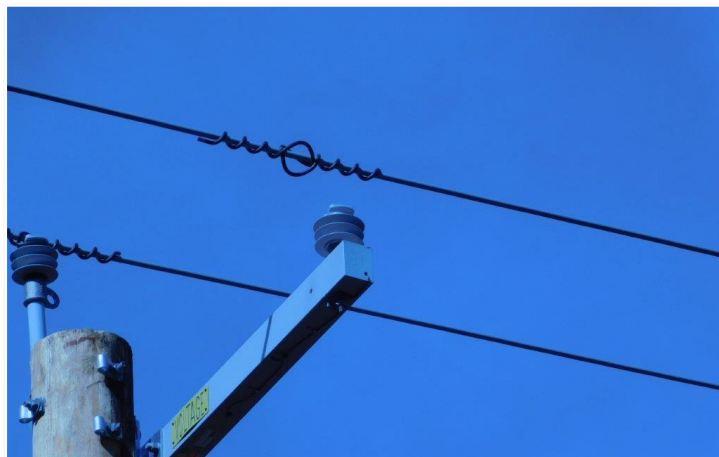
Below are floating conductors the Monitor team identified in Tier 3 areas and immediately reported to PG&E.

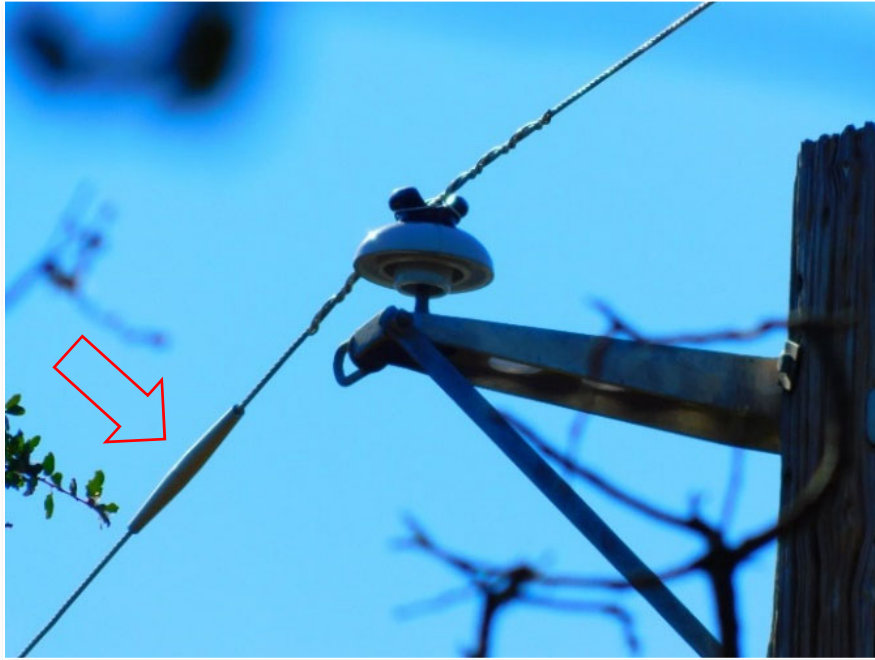
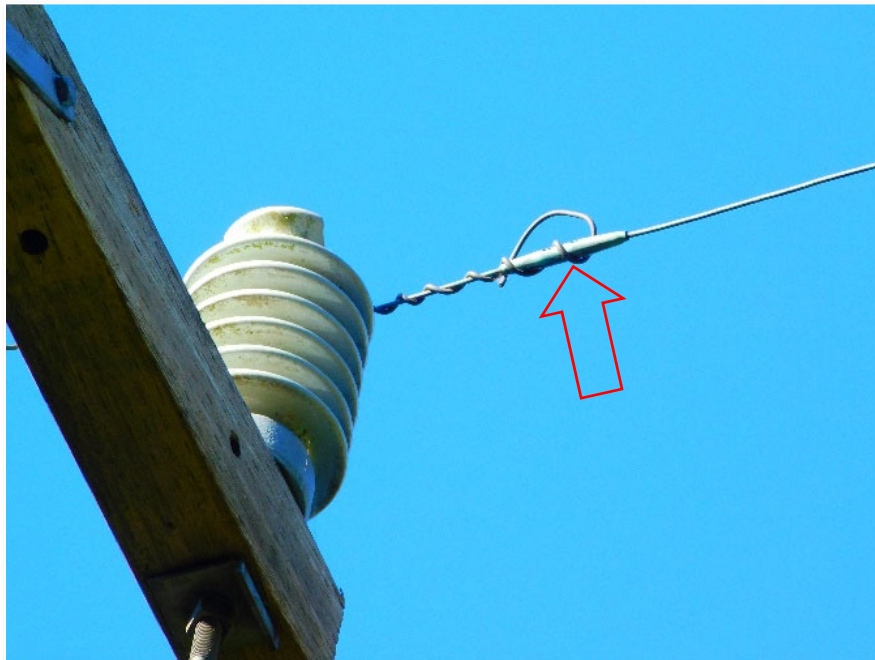
Below are conductors the Monitor team identified with splices tied in within 2' of an insulator.

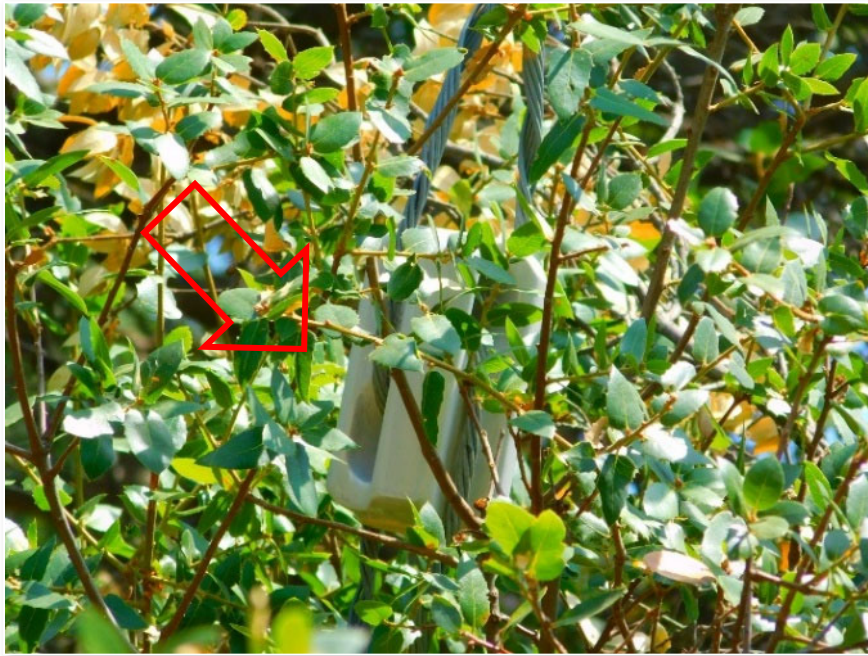
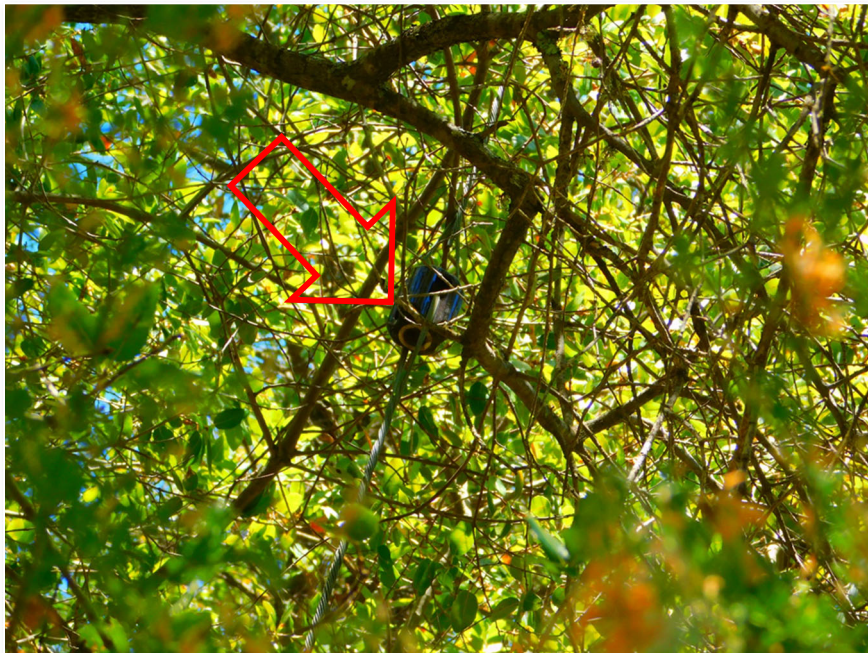
Below are examples found by the Monitor team where the guy wire was overgrown by vegetation.

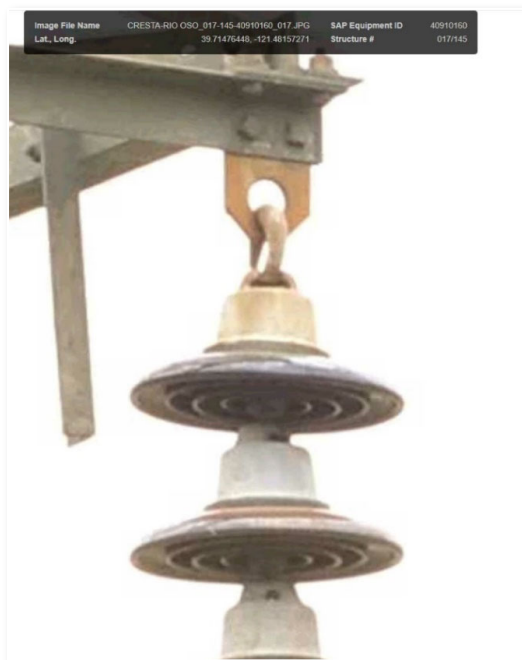
Below is a transmission structure on which the Monitor team observed a partially deteriorated C-hook and hanger plate.

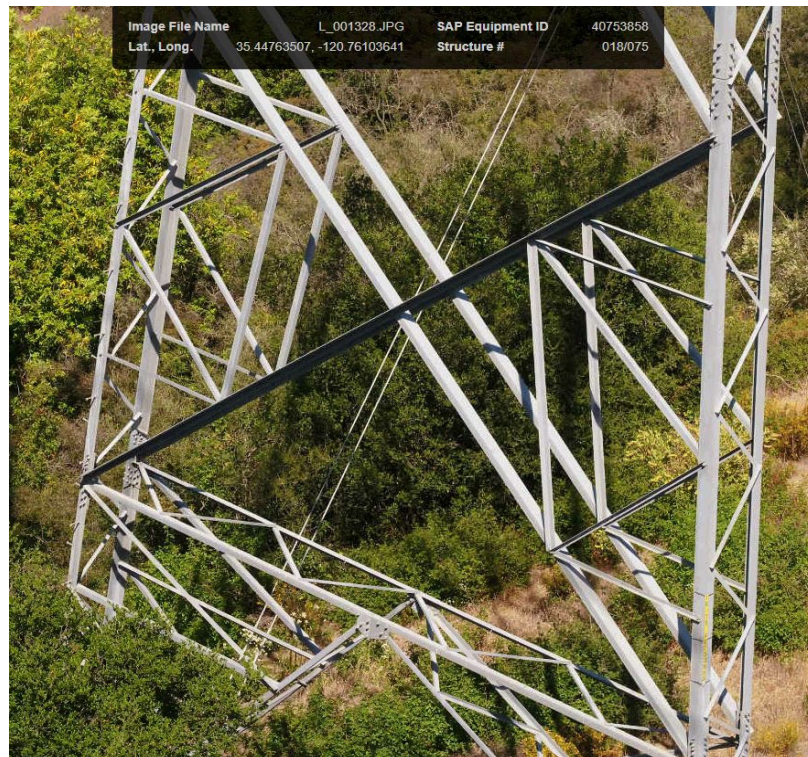
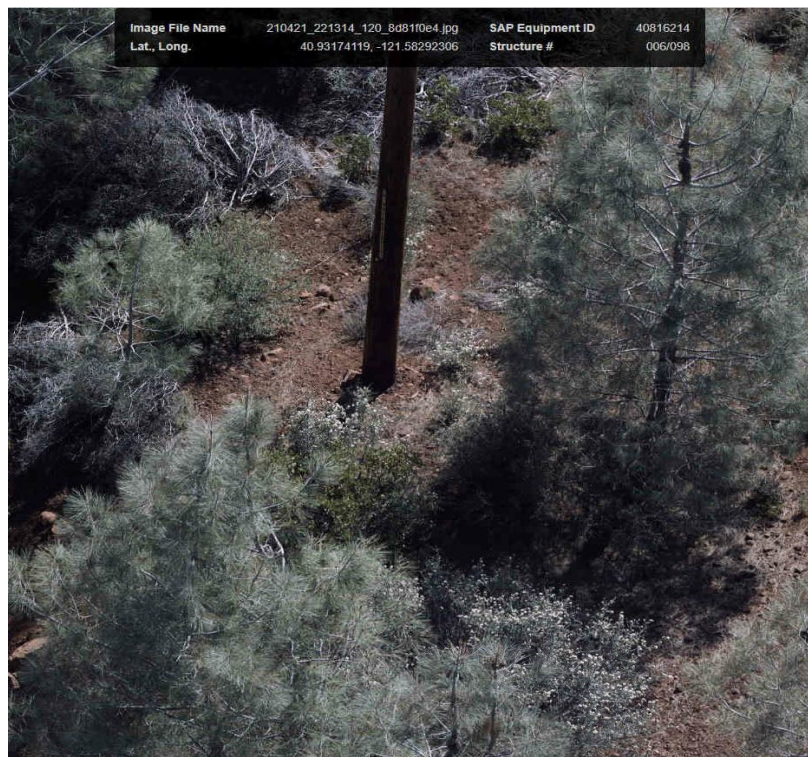
Below are structures the Monitor team identified that appeared to have vegetation present where PG&E inspectors did not note it.
